Filaments and Clarifier Bulking #2

Activated Sludge Plant that was close to having high flow washouts due to filamentous bacteria infestation.

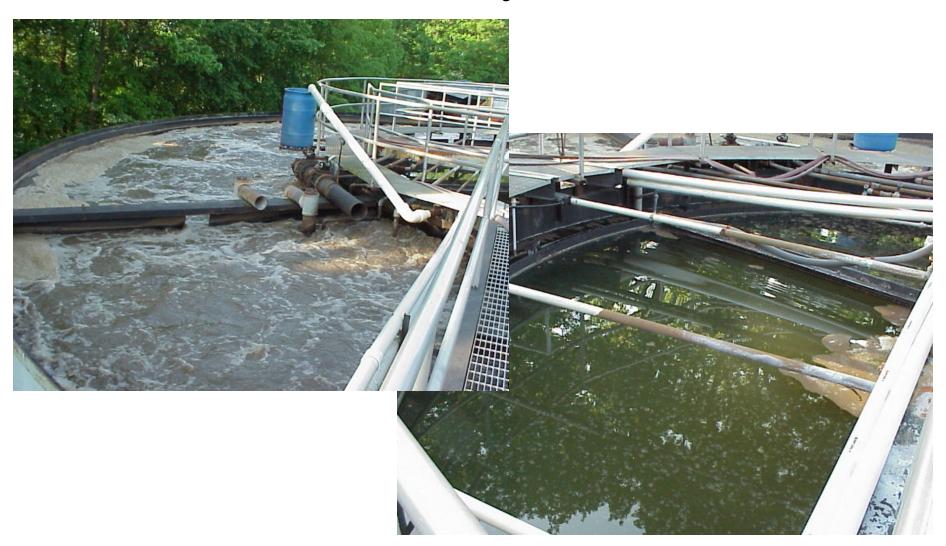
Can-Tex Style Plant

- Two Plants with the same layout
 - Headworks that serve both plants
 - Plug Flow Activated Sludge
 - Clarification
 - RAS pumped with air lift pump
- Aerobic Digestion

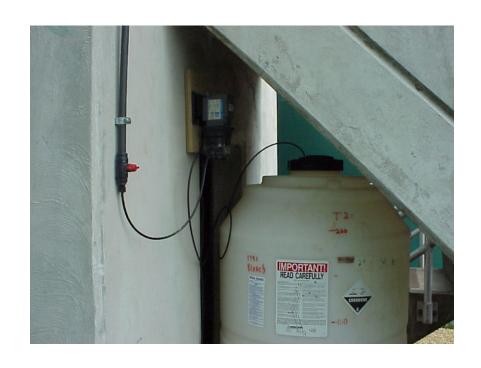
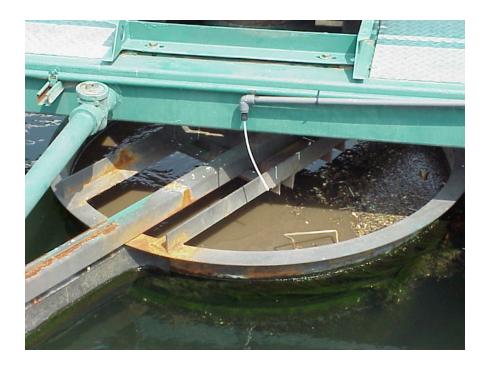
Chlorination System

- Dr Jenkins recommends that the Cl₂ be dosed in such a way that the mixed liquor receive three doses of Chlorine per day.
- In this plant the return sludge flow was not sufficient to achieve this so an alternative feed location was chosen.
- Bleach is to be feed into the clarifier stilling well

• 10 gallons per day of 12.5% Bleach is chosen
